THE ROSEBURG, OREGON, FIRE, EXPLOSION AND CONFLAGRATION

Disaster

August 7, 1959

Report by
THE NATIONAL BOARD OF FIRE UNDERWRITERS
85 John Street, New York 38, N. Y.
222 West Adams Street, Chicago 6, Ill.
465 California Street, San Francisco 4, Calif.
and
OREGON INSURANCE RATING BUREAU
721 S.W. Oak Street, Portland 7, Ore.

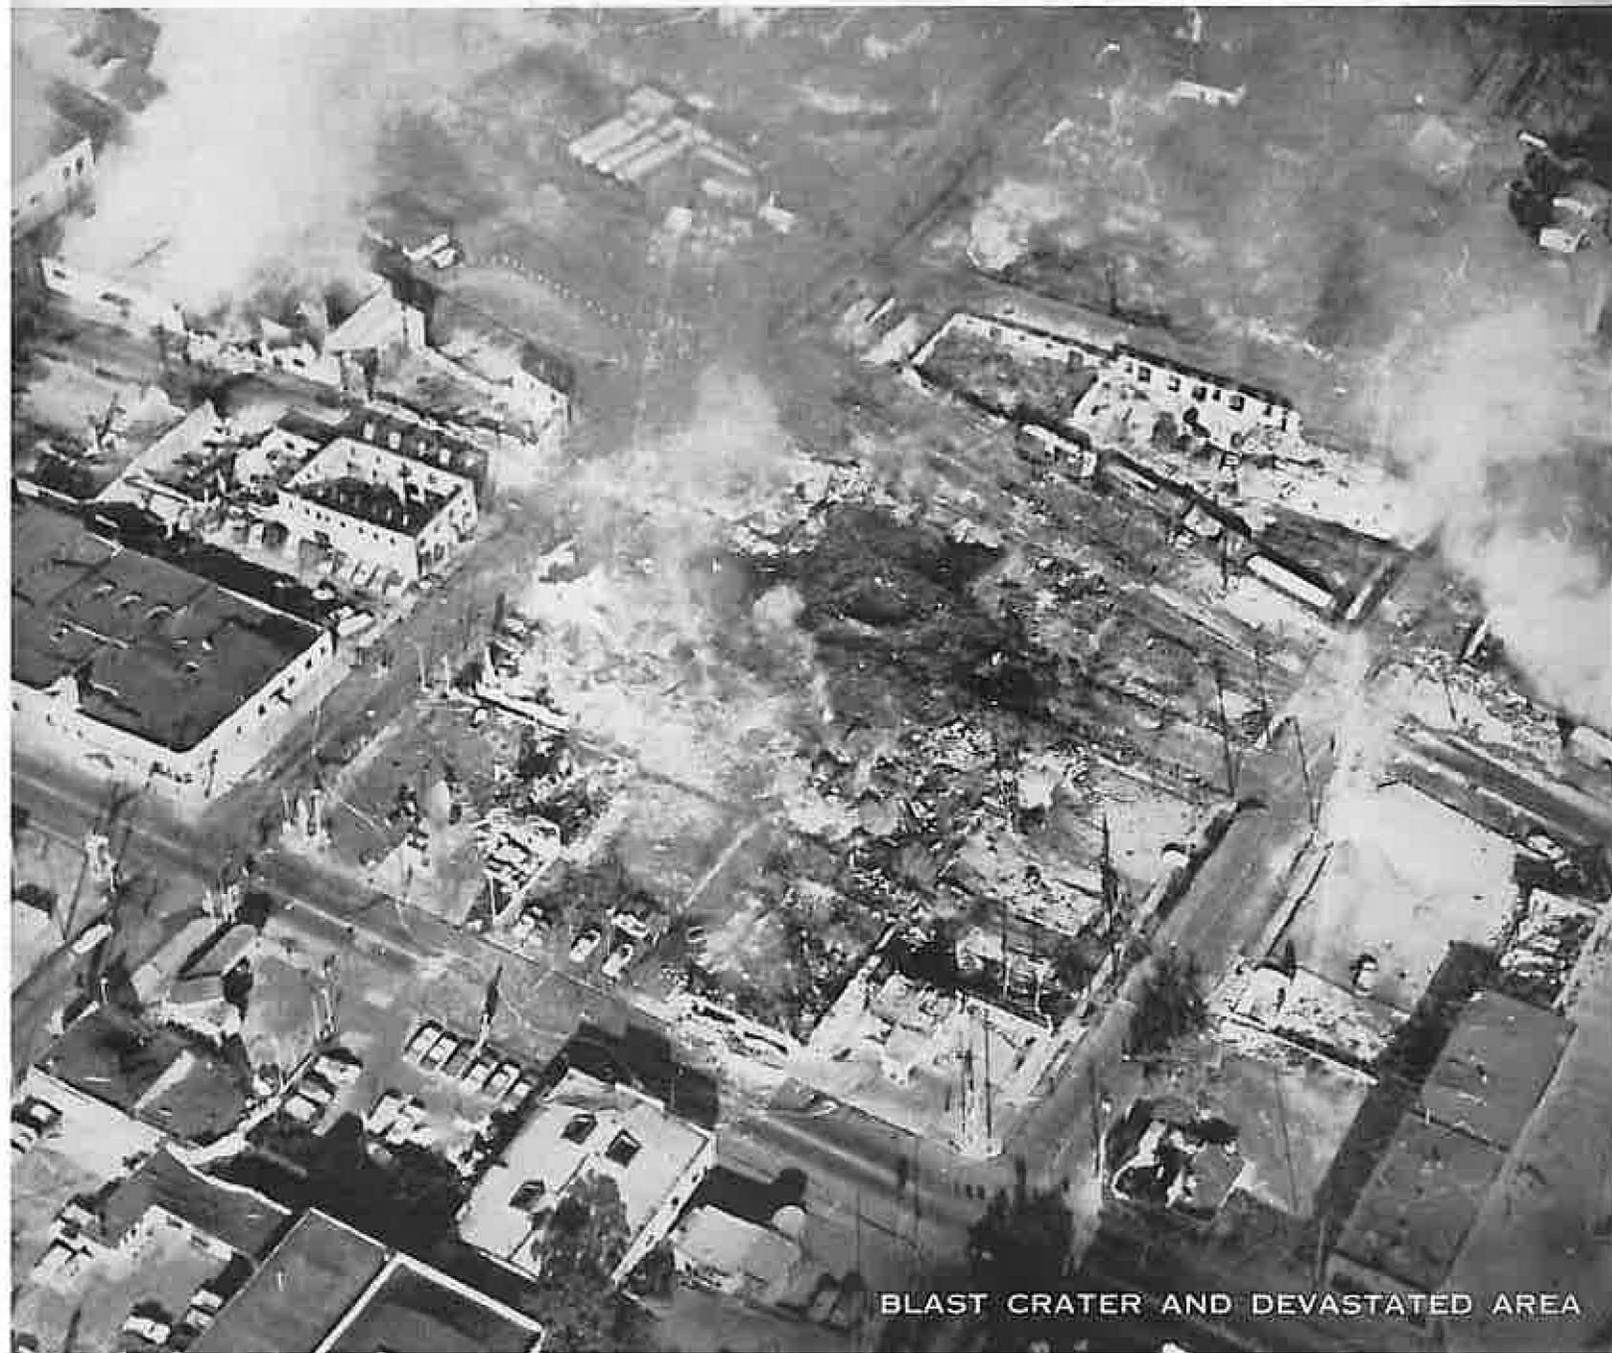
BLAST CRATER AND DEVASTATED AREA

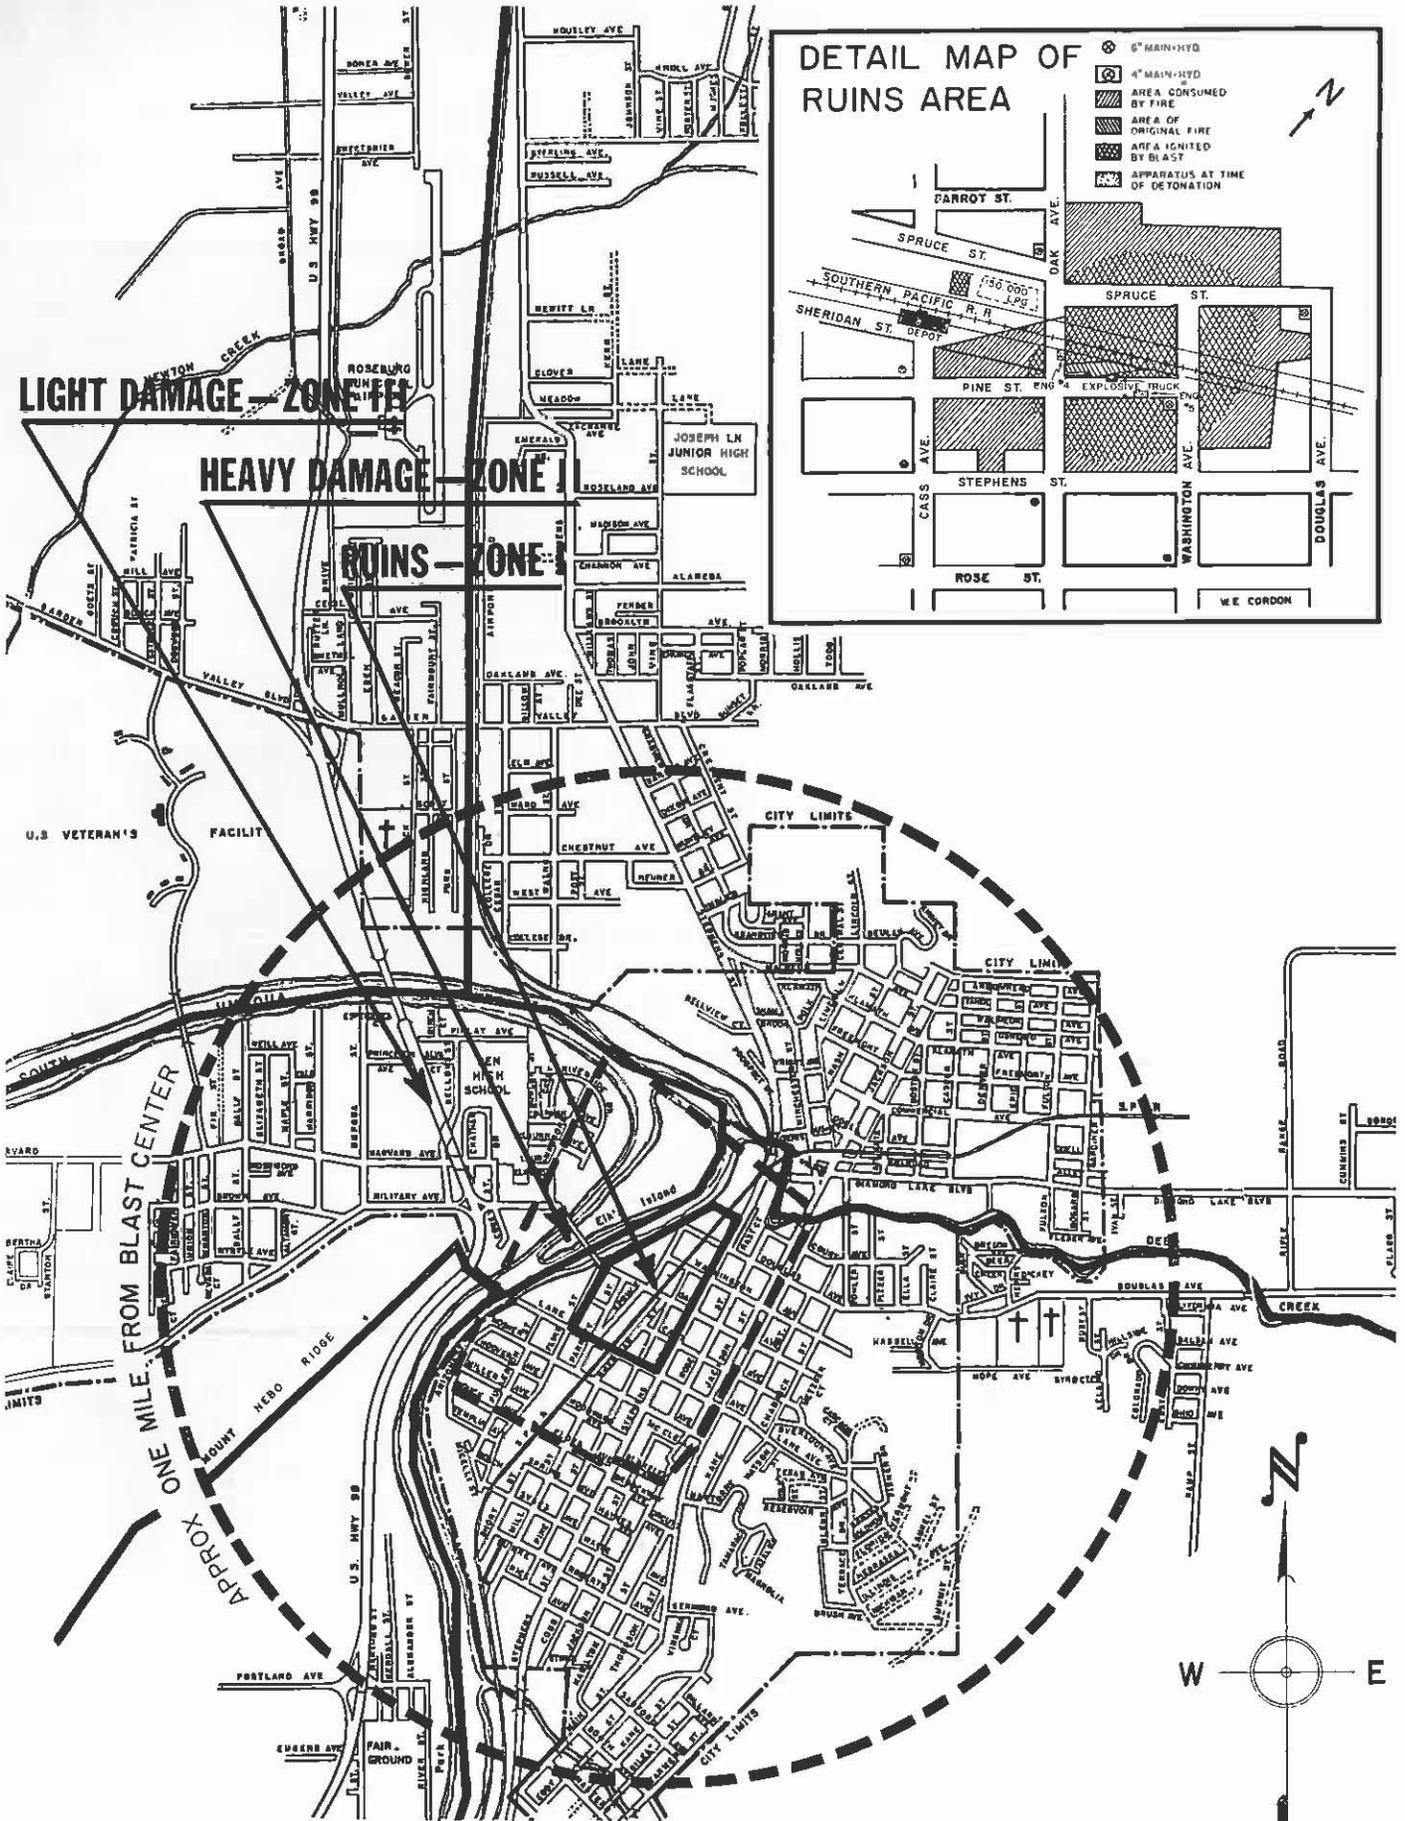
ROSEBURG & VICINITY - DAMAGE AREAS

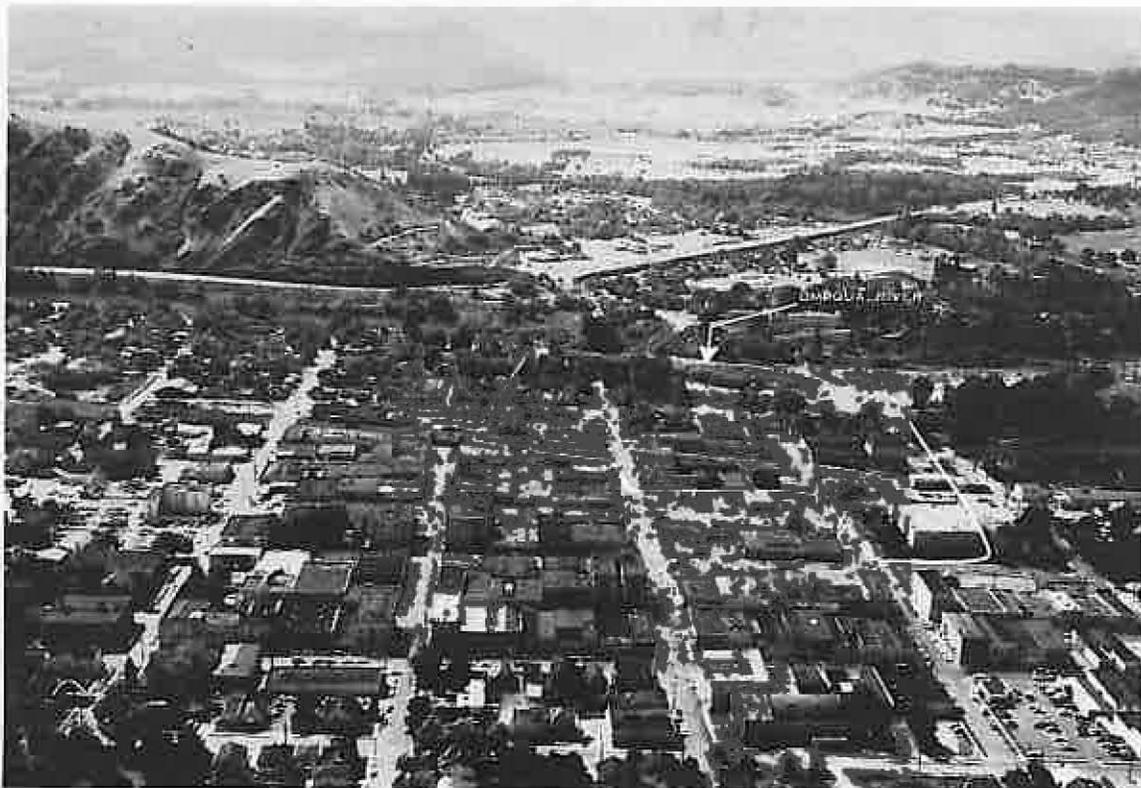
FIG. 1. Roseburg's business district—less than 3 weeks before the blast.
Outline shows area of heaviest damage.

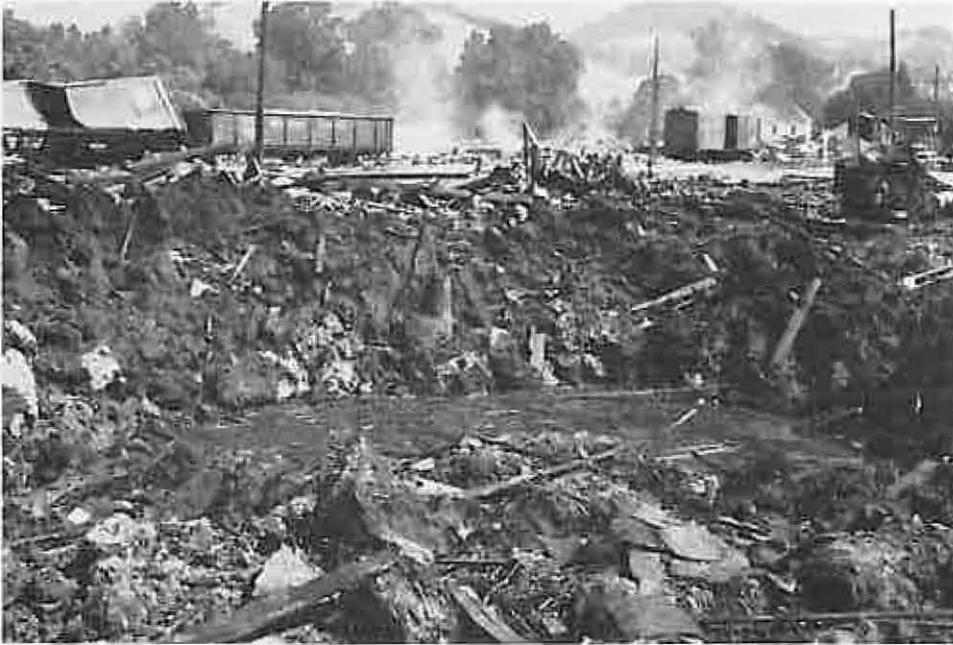
A crater 52 feet in diameter and 20 feet deep gave mute evidence to the terrific force of the blast. Most of the buildings in the immediate twelve blocks were completely destroyed. Hundreds of other buildings in the community suffered extensive damage over a 50-block area, and glass breakage was reported as far as 9 miles from the explosion. Tremors were reported as far away as 17 miles.

FIG. 2. Close-up view of crater—20 feet deep and 52 feet in diameter.

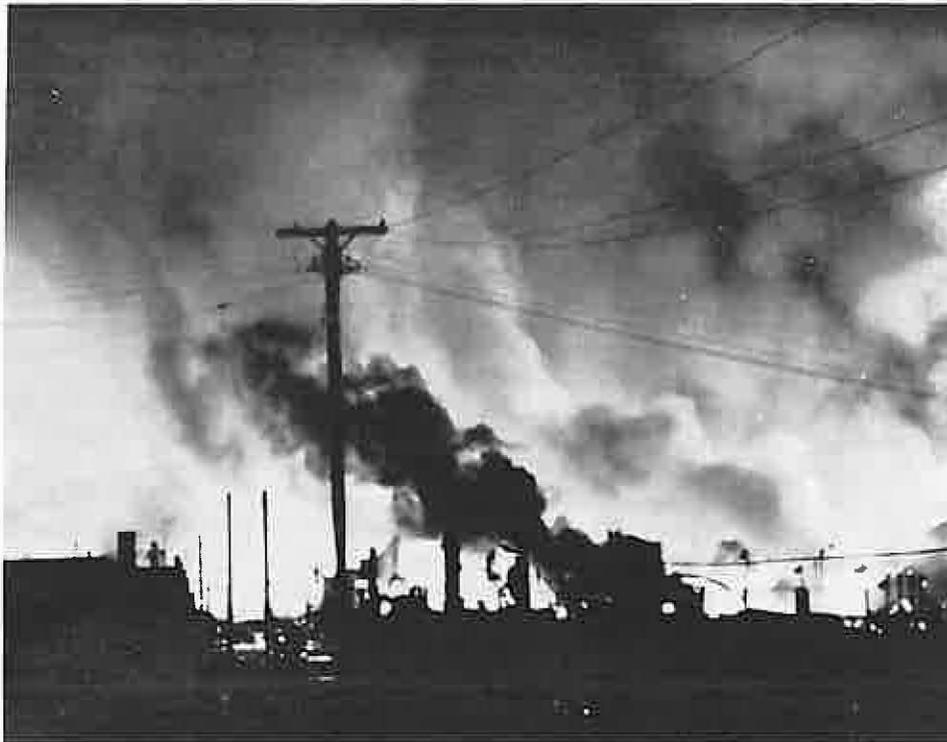
FIG. 3. View during conflagration looking west along Oak Avenue. Blast occurred 1 block behind black smoke.

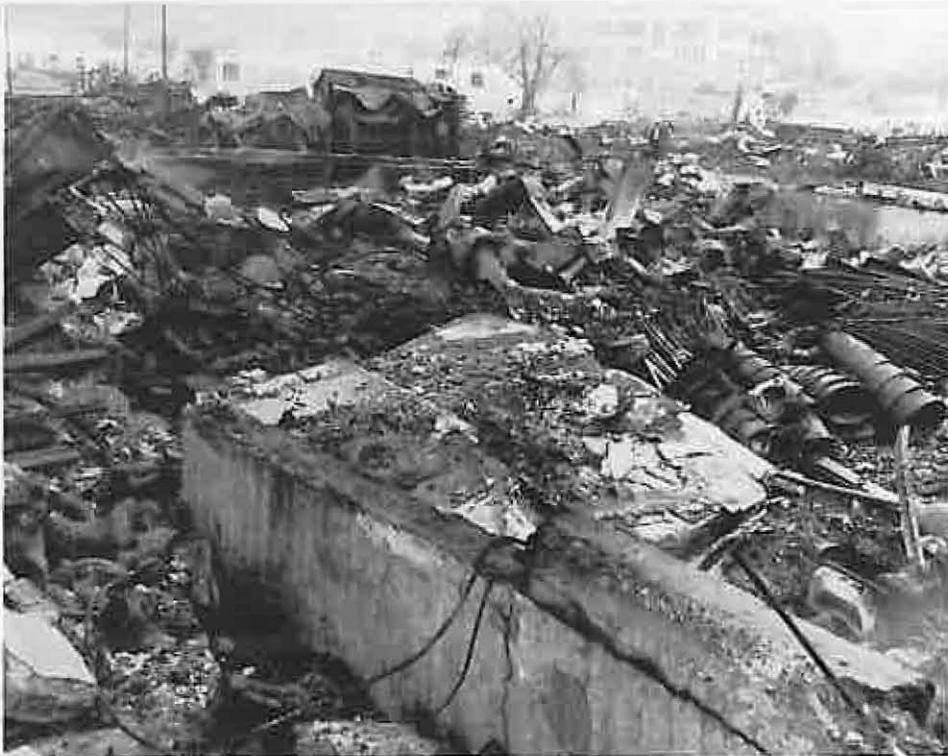
FIG. 4. Demolished Gerretsen Warehouse Building.

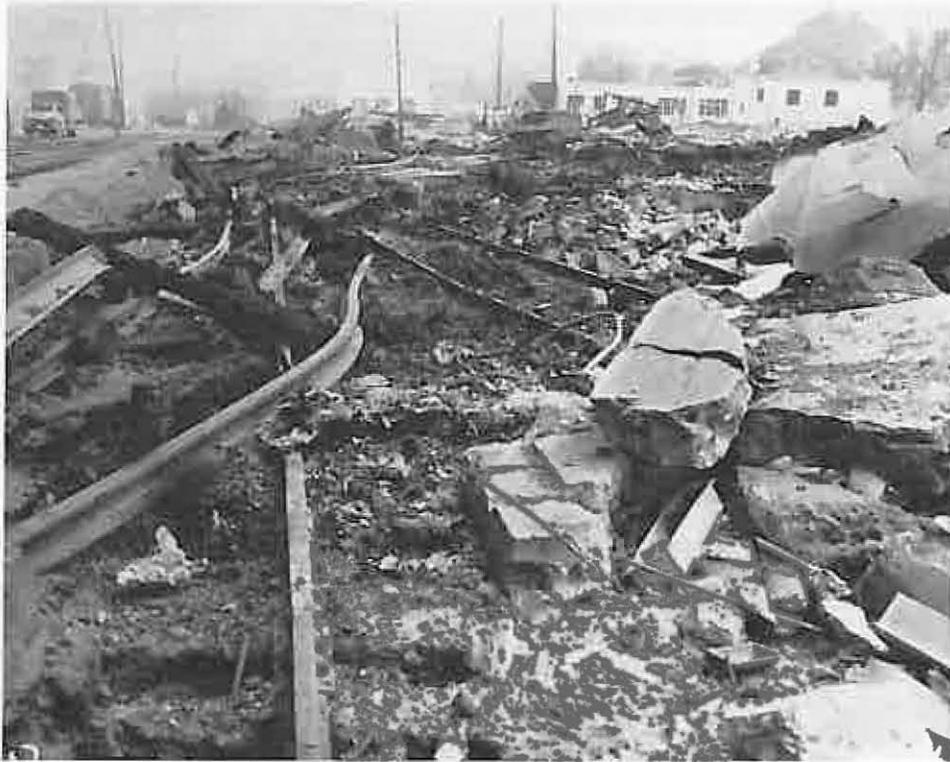
FIG. 5. Another view of damage in areas adjacent to the blast center.

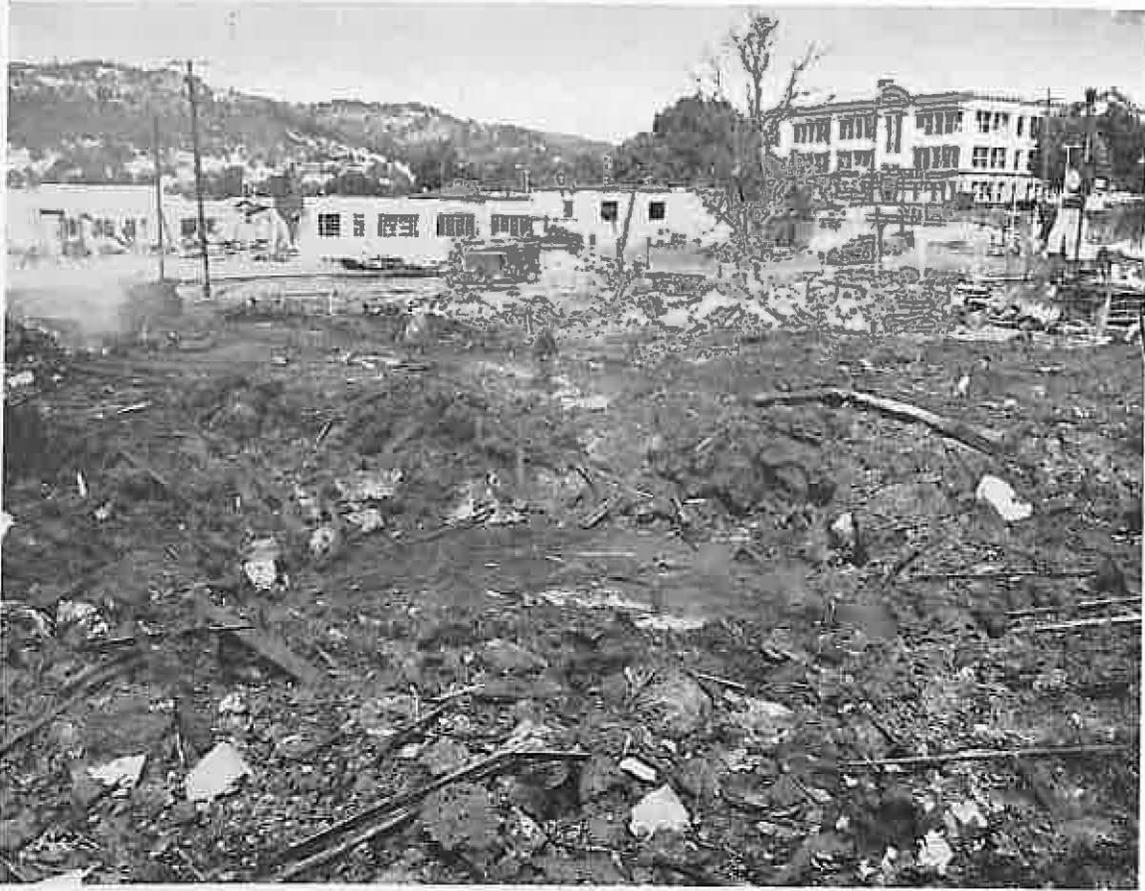
FIG. 6. Another view of damage area around crater. Note location of Junior High School building in upper right hand corner.

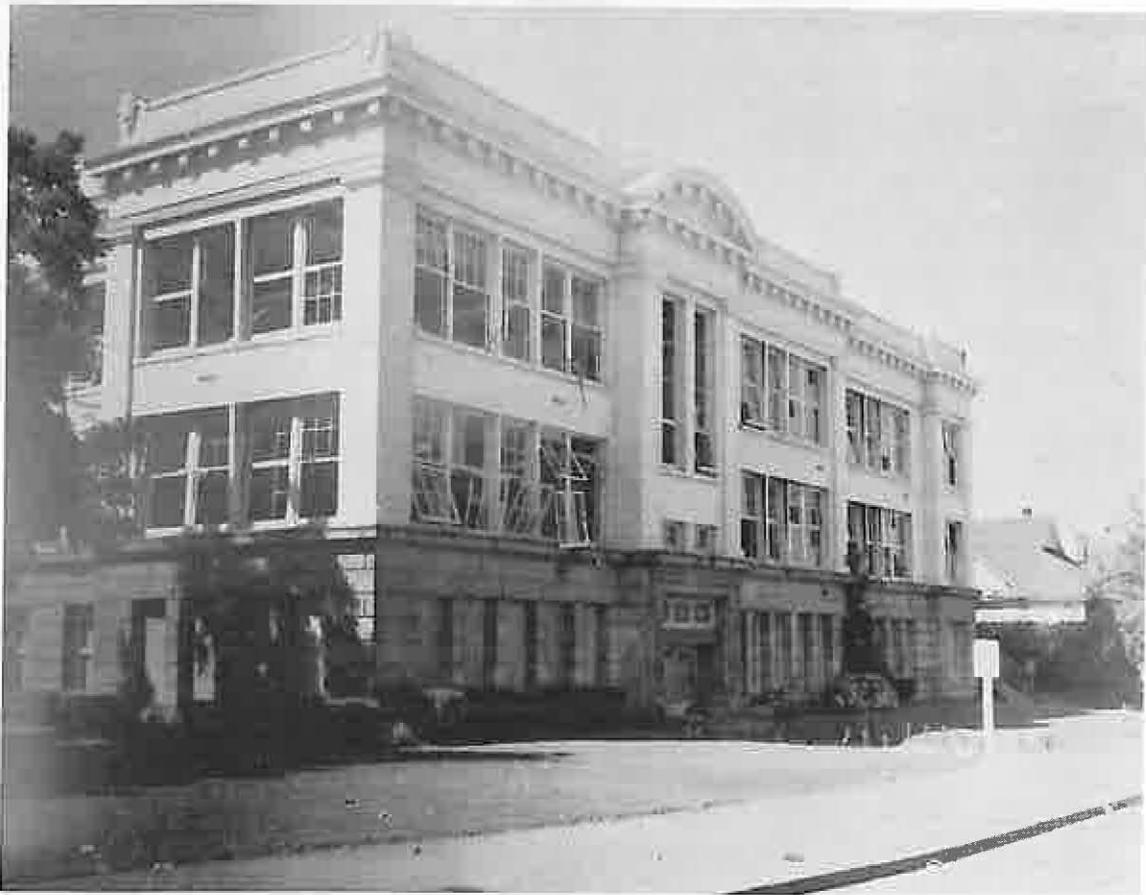
FIG. 7. View of damage sustained by Junior High School.

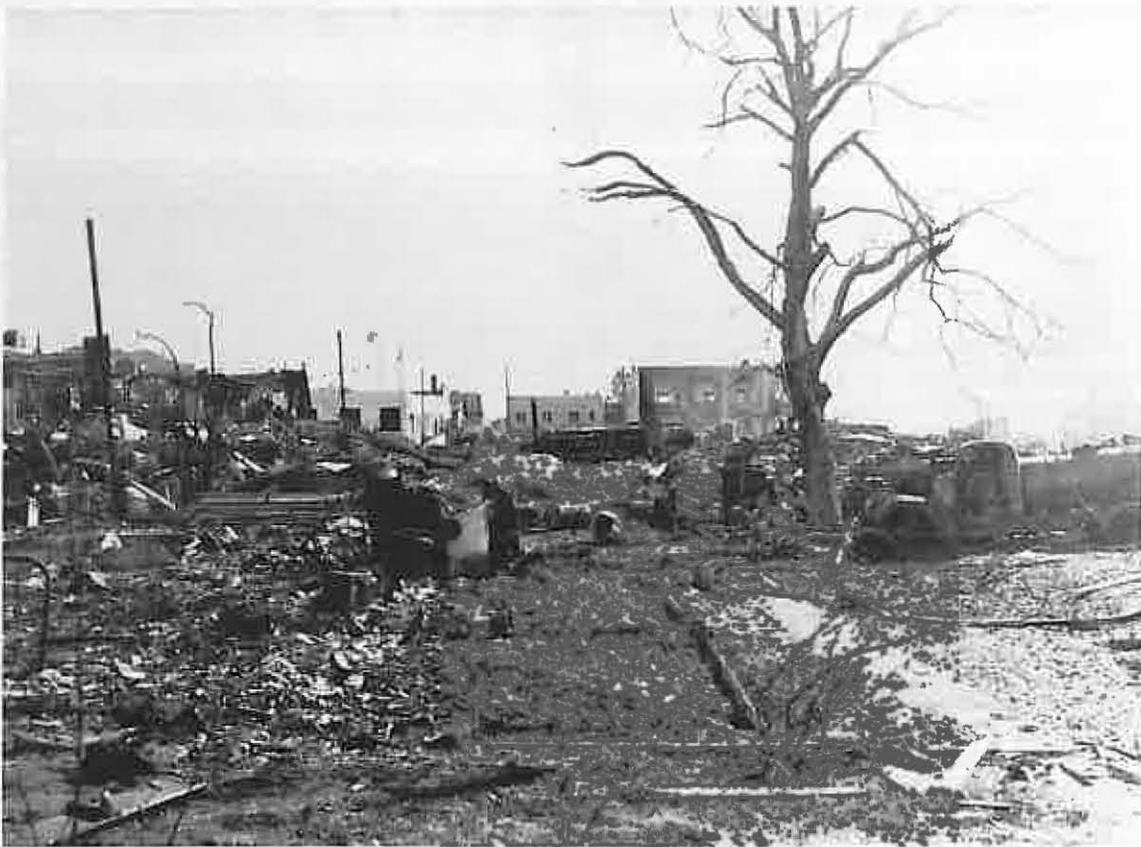
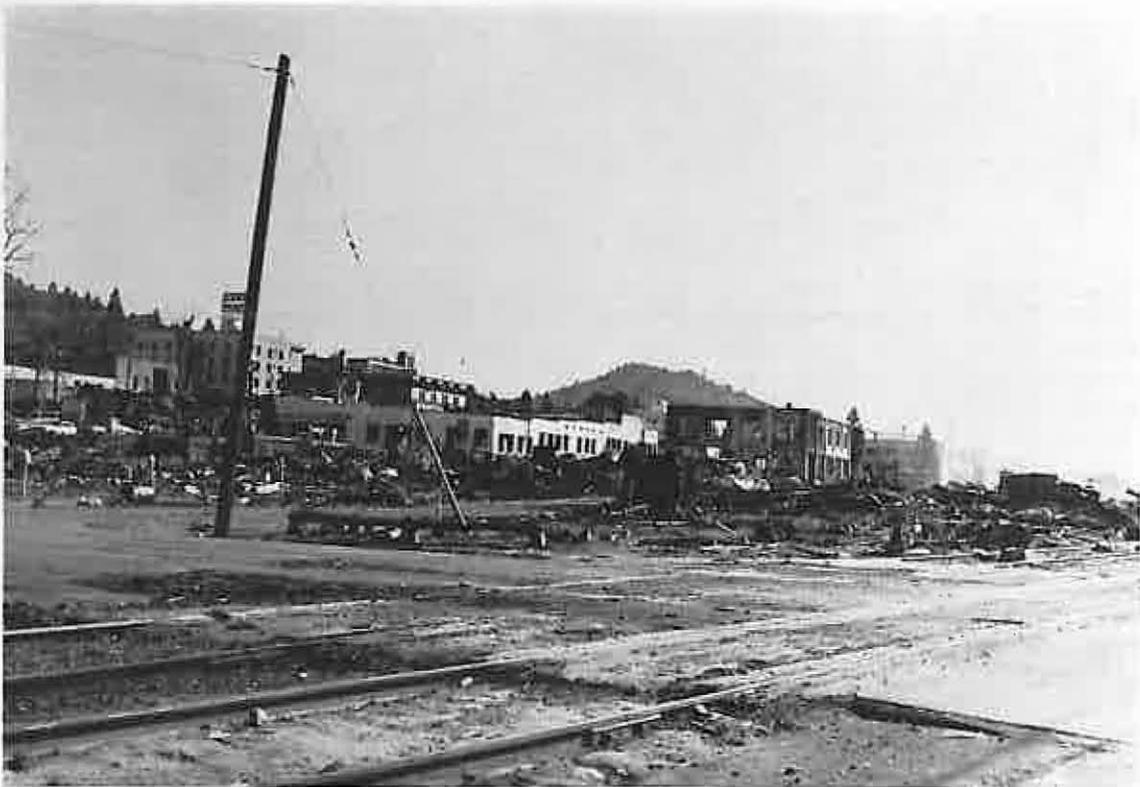
FIG. 8 and FIG. 9. Additional views of blast and fire damage.

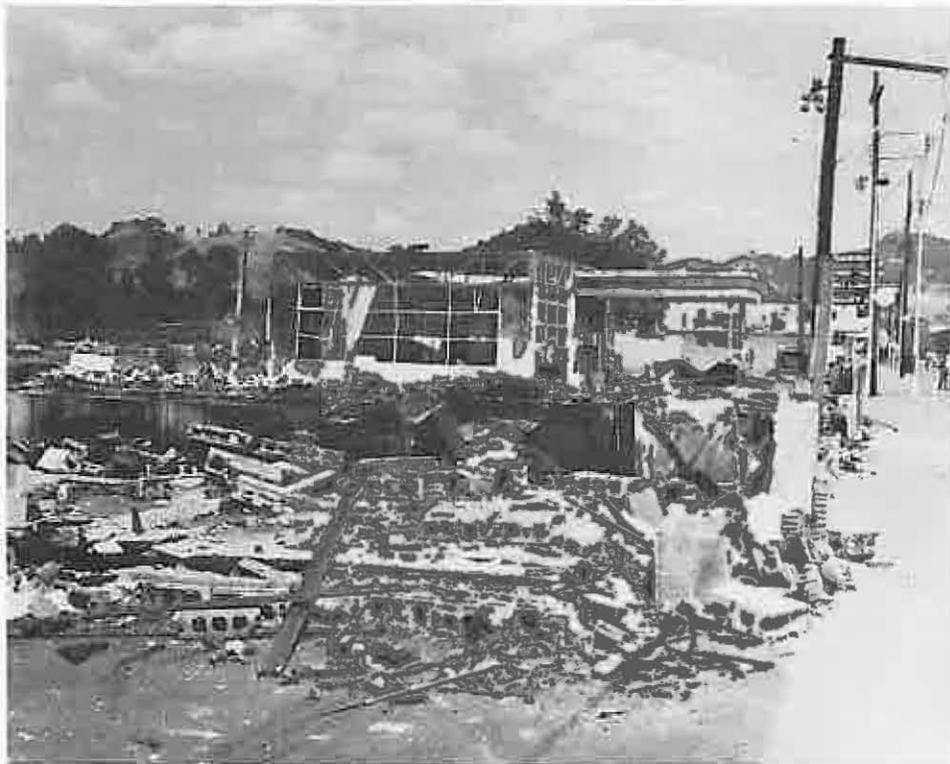
FIG. 10. Close-up view of typical structural damage.

Structural damage was due almost entirely to concussion and very little to flying missiles. Except in the immediate blast area where destruction was practically total, wood frame exterior walls in nearby blocks were generally badly damaged. Concrete block walls, usually 8 inches in thickness and almost entirely without steel reinforcement, frequently suffered total or partial collapse. On the other hand, older brick walls and poured concrete walls generally remained intact; an exception was the parapets which, lacking the lateral support and thickness of the walls below, were often found cracked. Interior plastered partitions were bulged or displaced where the blast wave entered through shattered windows. In some such cases, buildings did not appear to be badly damaged until an examination was made of the interior. New type light partitions such as wall board fastened by metal clips stood up very poorly.

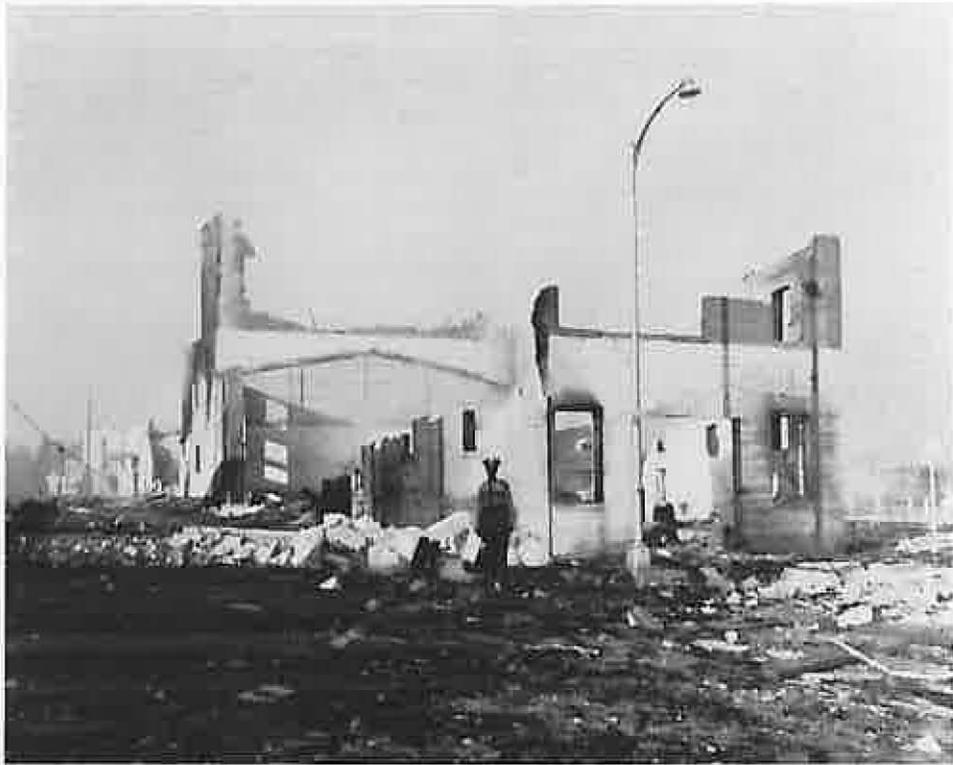
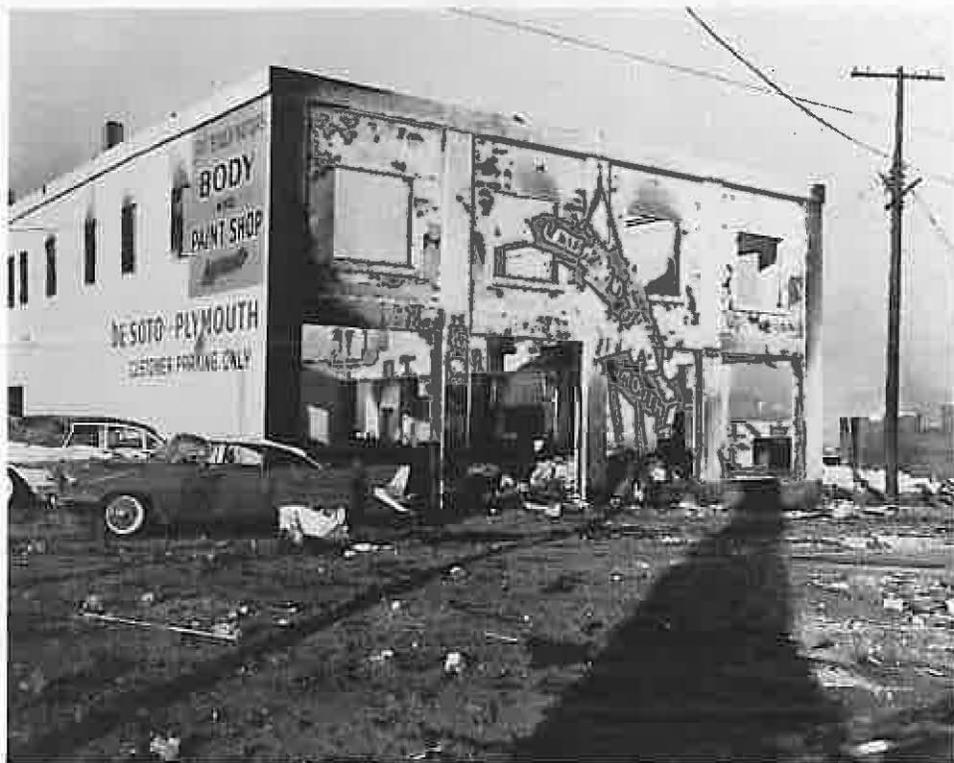
Roof construction suffered heavy damage, in many cases roofs being subjected to upward forces (for which they were not designed) and then dropped to a mislocated position. This action caused failure in upper and lower chords and end details of trusses and split numerous rafters. This type of damage was characteristic in garages. In 2-story and higher buildings, damage was not

FIG. 11 and FIG. 12. Close-up views of typical structural and fire damage.

nearly so common to floor joists as to roof joists. Numerous plaster and wallboard ceilings and fixtures fell, and plaster damage was extensive in hotels and stores. Buildings for a distance of many blocks from the blast source had most or all windows shattered, and in the Junior High School and a number of other buildings, window frames were dislodged, some being blown inward and some outward, in the same building. Shattered window glass penetrated clothing, furniture and other displays in show windows and food, merchandise, and floor coverings in stores. Proprietors burned wearing apparel, mattresses, and other items where glass splinters were considered a possible menace to the consumer. Churches bore heavy losses to stained glass windows.

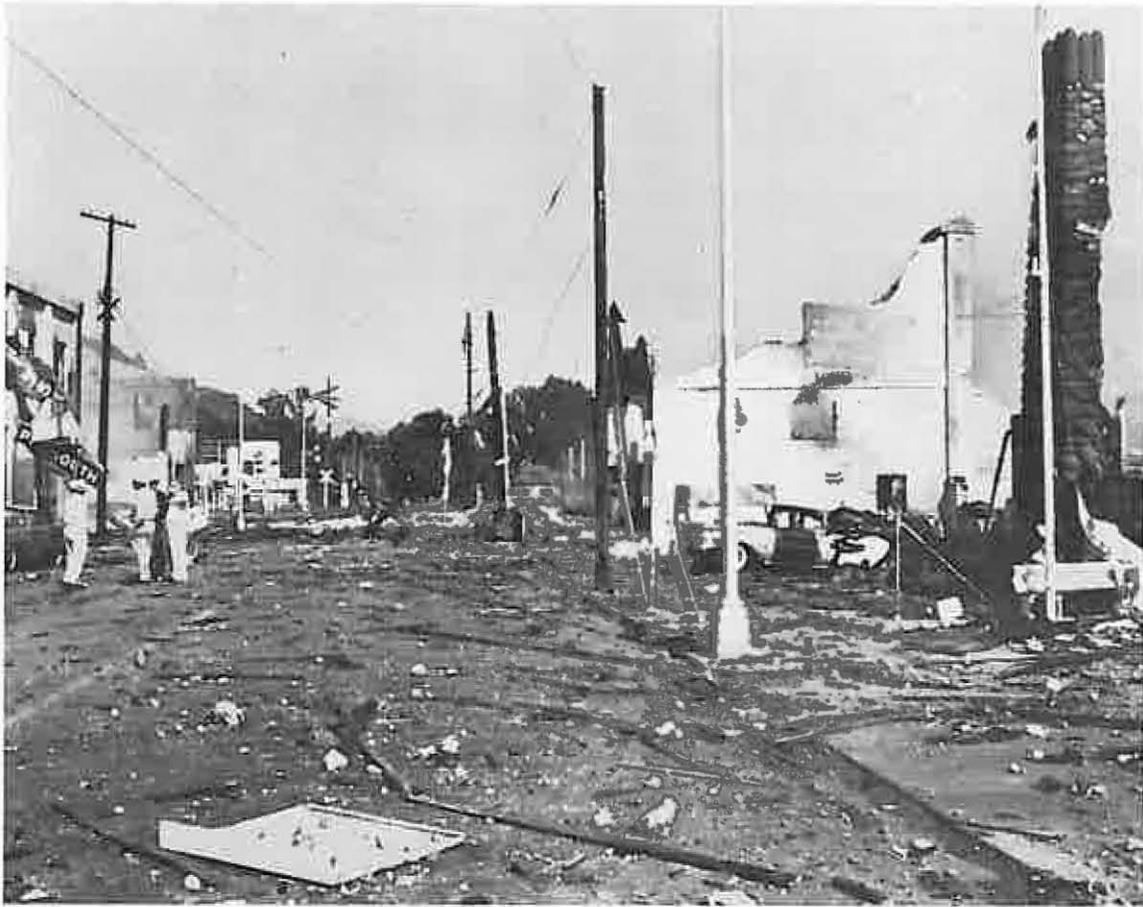
FIG. 13. View looking west on Oak Avenue after conflagration was brought under control.
